Seismic Risk Consulting Report

Beach Cities Health Center
514 North Prospect Avenue
Redondo Beach, CA 90277

**Report: Seismic Risk Consulting – Beach Cities Health Center
514 North Prospect Avenue, Redondo Beach, CA 90277**

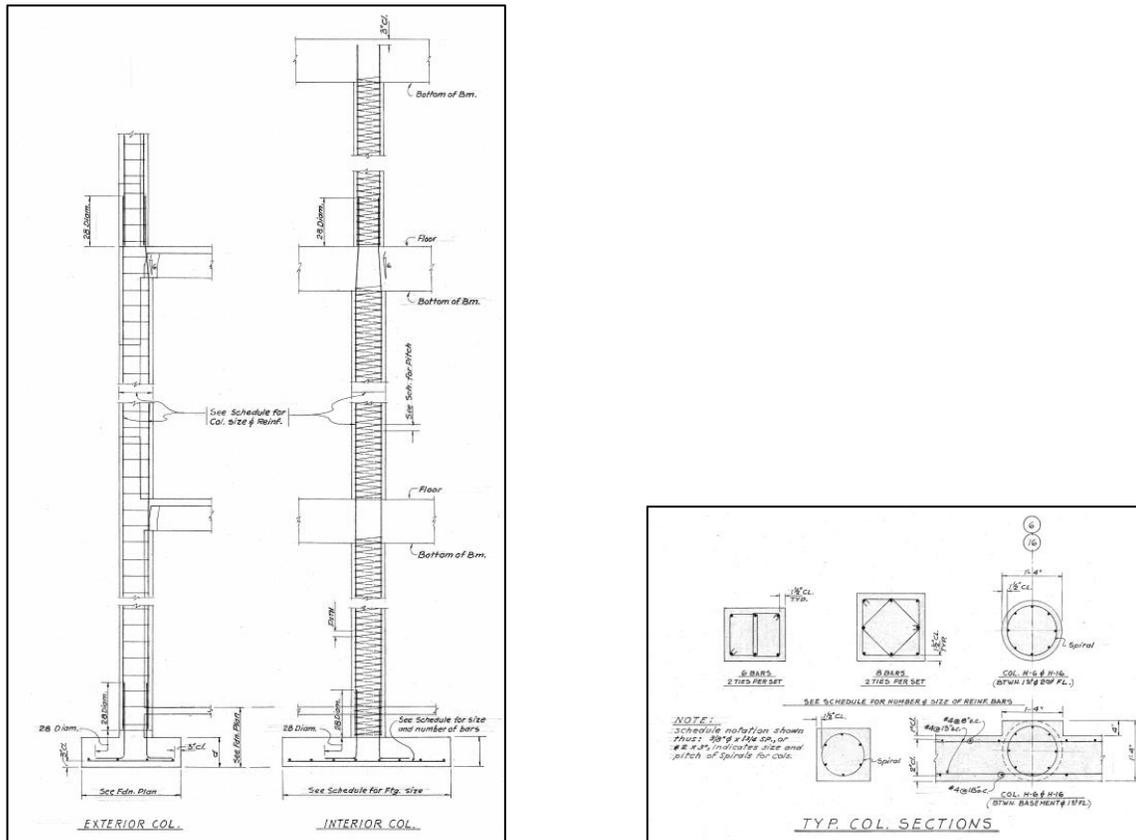
Figure 5 – Column Elevation and Details (North Tower)

- Reinforced concrete columns have rectangular sections of various sizes, with #7, #8 or #9 vertical bars and #4 ties spaced at 4 to 10 inches on center for columns on exterior lines. Interior columns have #3 ties spaced at 4 to 10 inches on center. Insufficient transverse reinforcement and lack of ductile detailing -- especially for the interior columns -- may lead to brittle shear failures when subjected seismic lateral movement (i.e., inter-story drift).

- Deep spandrels typically have #4 ties spaced at 12 inches on center (limited cases were seen with double #4 ties at 12 inches on center). These spandrels create captive columns along the east and west side the building that are prone to brittle shear failure during a seismic event.

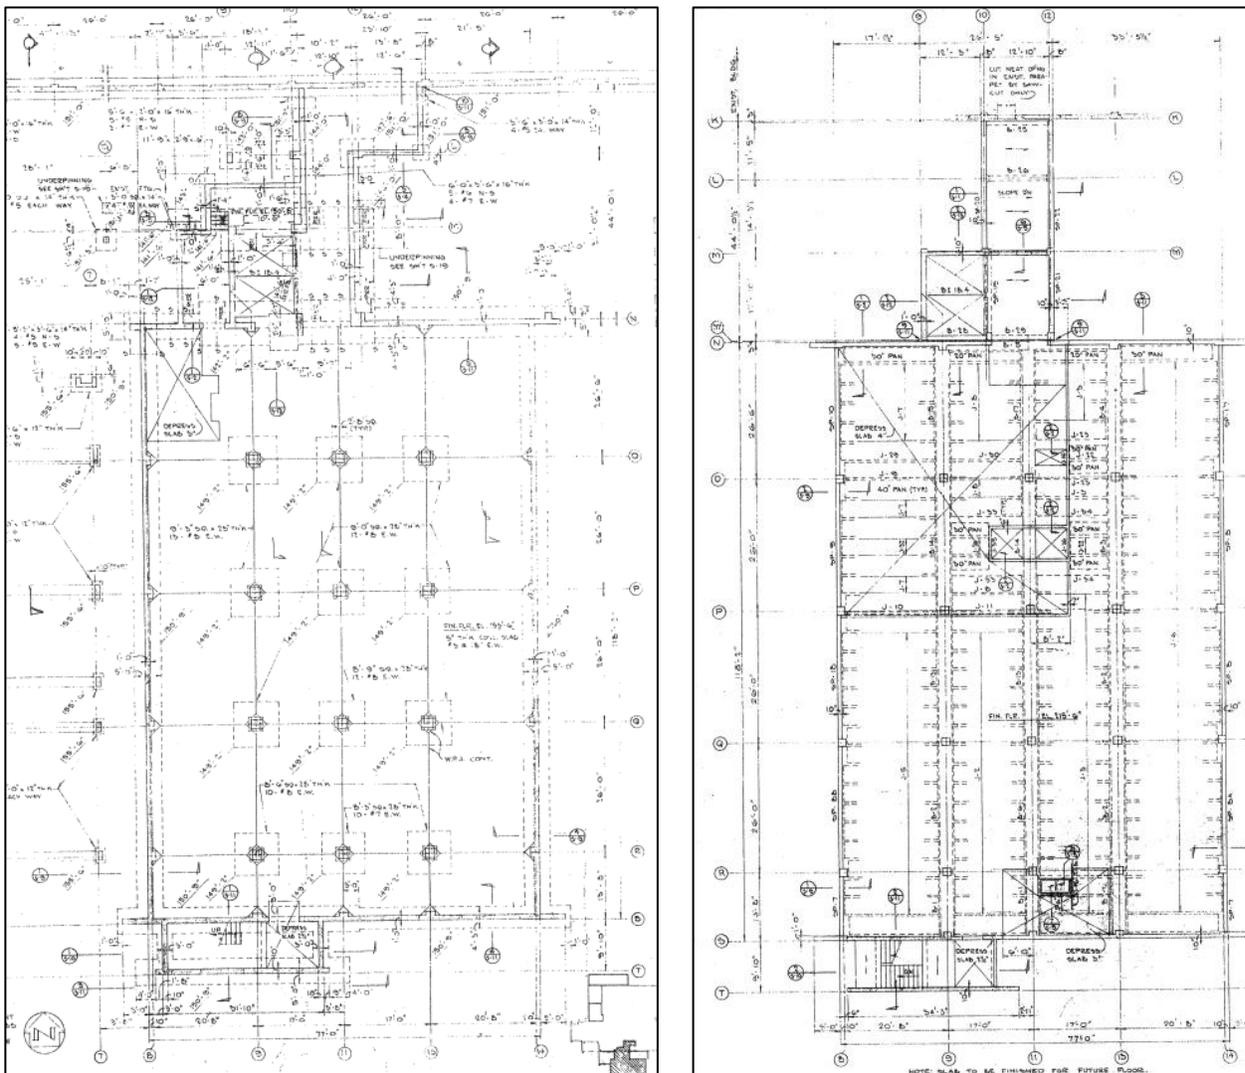
Figure 6 – Foundation and Basement Plan (Left), Roof Level Plan (Right) (South Tower and Elevator Tower)

- The roof-top mechanical penthouse has reinforced concrete shear walls around its perimeter.
- The building has vertical irregularity deficiency in parts of the lateral load resisting system where discontinuous shear walls are supported by beams or columns of lower floors (e.g., penthouse shear walls supported by roof beams and a column at the basement along the north

side of the building supporting another discontinuous shear wall). This condition may lead to additional seismic damage and overstress in the supporting members.

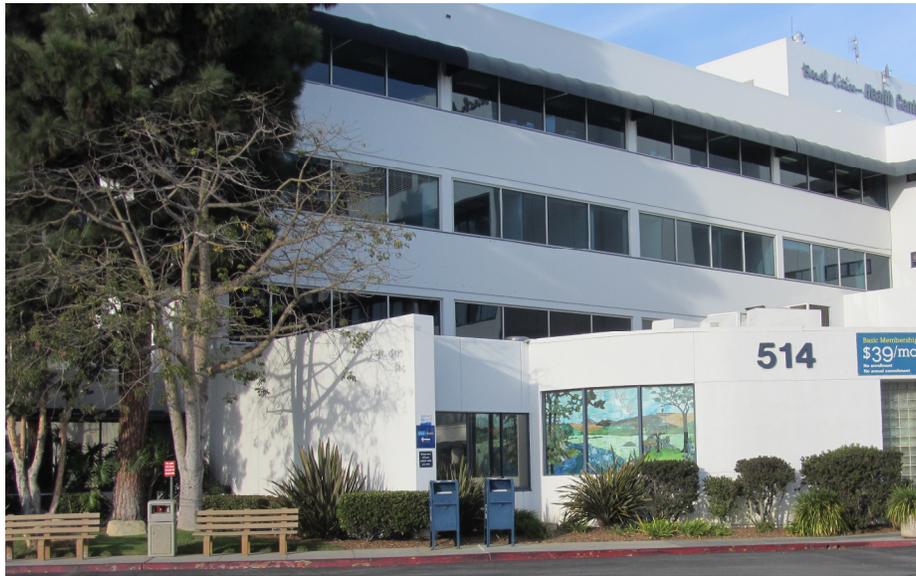
The lateral force resisting system for the north tower consists primarily of concrete shear walls in both directions of the building. There are also deep concrete spandrels framing to concrete columns along the north and south sides of the building that act as moment frames (refer to figure 2). The floors and roof contain concrete slabs that form rigid diaphragms that distribute seismic induced forces to the walls and frames.

Figure 2 - View of South Side of North Tower

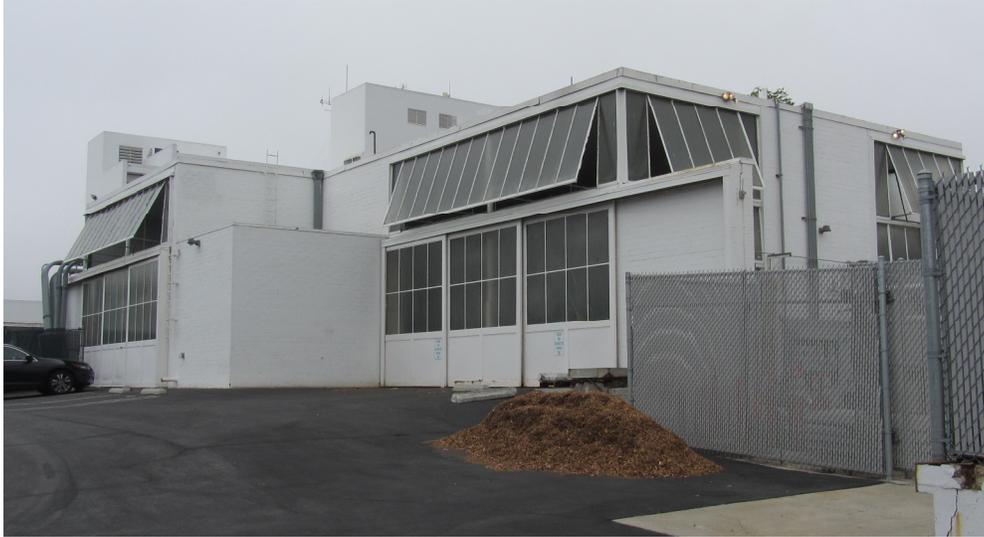
The lateral force resisting system of the central plant consists of reinforced masonry shear walls around the perimeter of the building. The roof consists of a plywood diaphragm and anchors connecting the perimeter masonry walls to the timber framing (refer to figure 3).

Figure 3 -View of Central Plant
